## **REPRESA DE FERROCEMENTO “LAS TORTUGAS”**

## **FERROCEMENT DAM “THE TURTLES”**

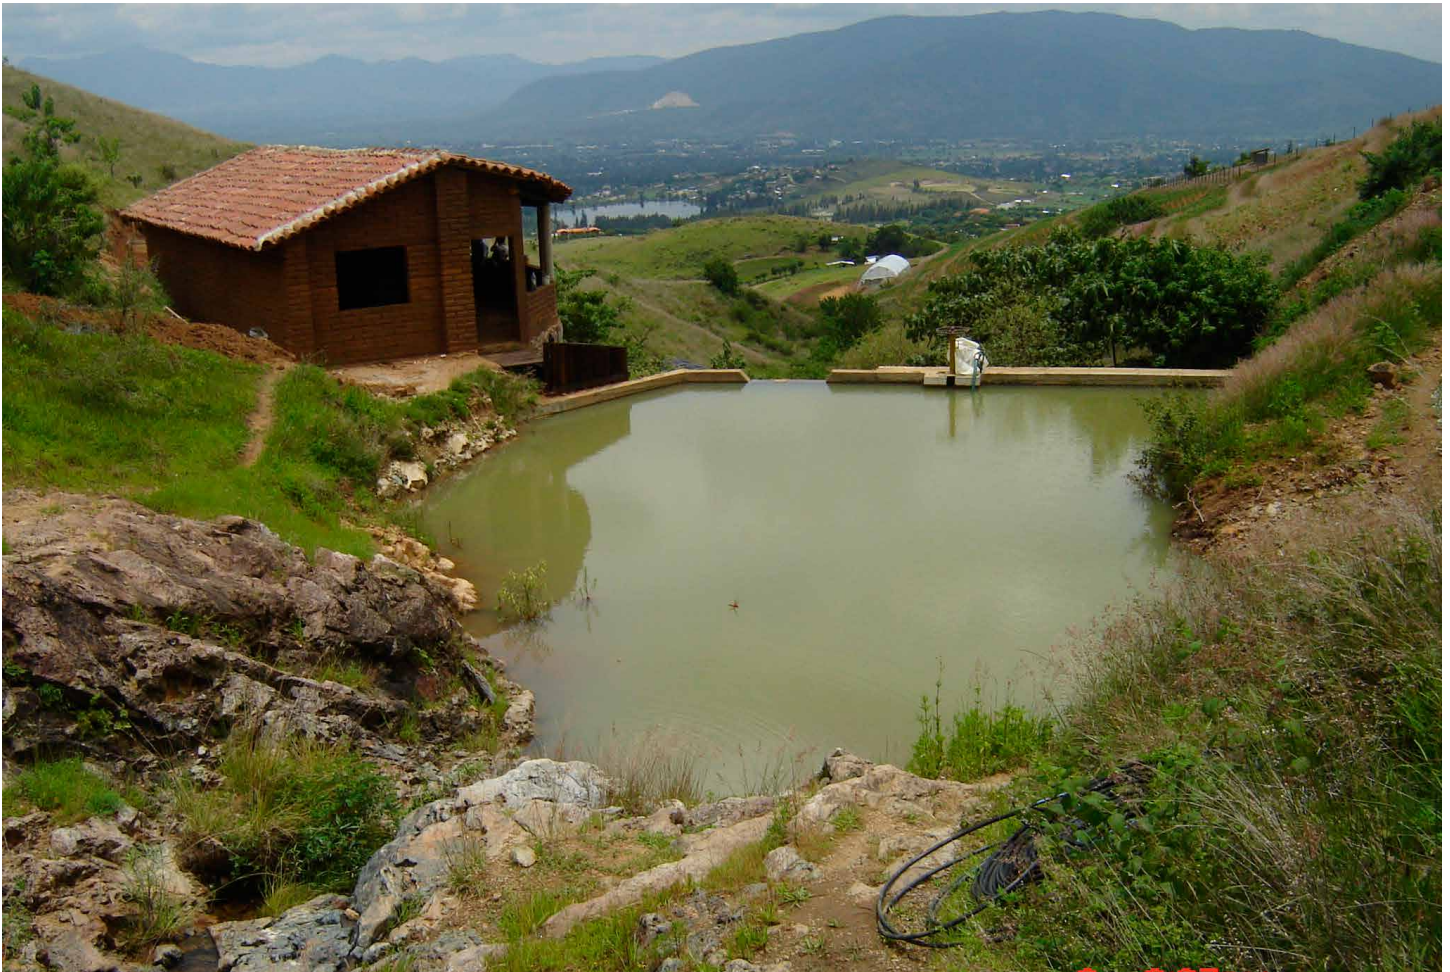
Se construyó en 2005 y hasta 2009 el agua captada se infiltraba al subsuelo con relativa rapidez. A partir de 2010 el agua se ha conservado durante más tiempo en el vaso de la represa y ahora ya dura los siete meses de estiaje. Su uso principal es para riego y se puede observar que el agua infiltrada brota nuevamente en la micropresa de lodo y arena que se encuentra arroyo abajo. Está construida con un muro de ferrocemento que tiene una cortina de 16 m. con una compuerta volante vertedora, su base es semi-permeable y tiene una capacidad de almacenaje de 1 millón 200 mil litros.

*It was built in 2005, and until 2009, the water that was collected seeped into the ground relatively quickly. Since 2010, the water has remained in the reservoir of the dam for a longer period of time, and now lasts for the seven months of drought. It is primarily used for irrigation, and one can observe that the filtered water flows into the microdam of mud and sand that is located downstream. It is made with a wall of ferrocement that has a curtain of 16 m. with a wheel gate spillway, its base is semi-permeable, and it has a storage capacity of 1 million 200 thousand liters.*
